Heritage Hills Metropolitan District

Heritage Hills Parkway Speed Study

IMEG #21000593.00

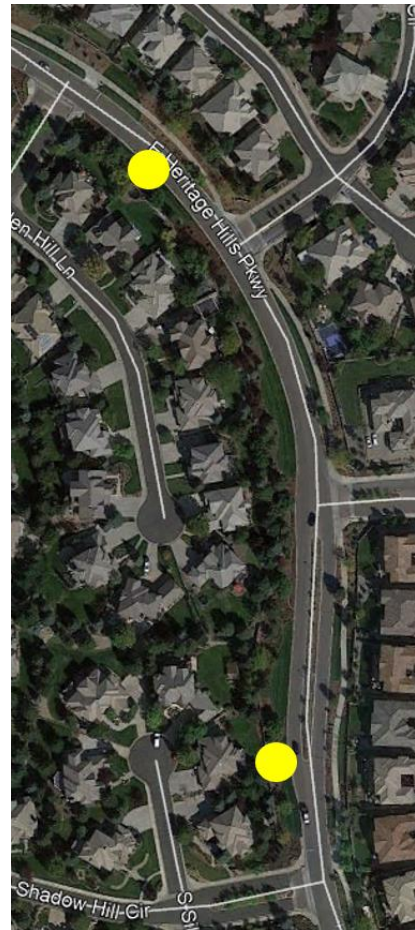
1. Segment 1 - Hidden Hill Place to Shadow Hill Circle

Segment 1 Study Area consists of a length between Hidden Hill Place and Shadow Hill Circle of approximately 1,185 feet. The following data summarizes the findings of this segment:

- 140 trips per day (Average)
- Minimum Speed = 12.5 MPH
- Maximum Speed = 53.7 MPH
- **85th Percentile Speed = 33.5 MPH**

There are two intersections within this segment of which no volume or speed data was collected and analyzed for this study. The intersecting streets were Aspen Hill Circle and Vista Hill Circle. Since no data was collected for these movements, the only trips accounted for with this data set is for movements completed from the intersection of Hidden Hill Place to Shadow Hill Circle.

Upon reviewing the data collected, it is noted that the 85th percentile speed is 34 to 45 percent higher than the posted speed limits for both sections. According to the MUTCD, engineers recommend setting the posted speed limit at the 85th percentile speed. This is a quantitative indication that there are excessive speeds along the Parkway or that the posted speed limit should be adjusted to 35 miles per hour to be consistent with vehicle speeds.

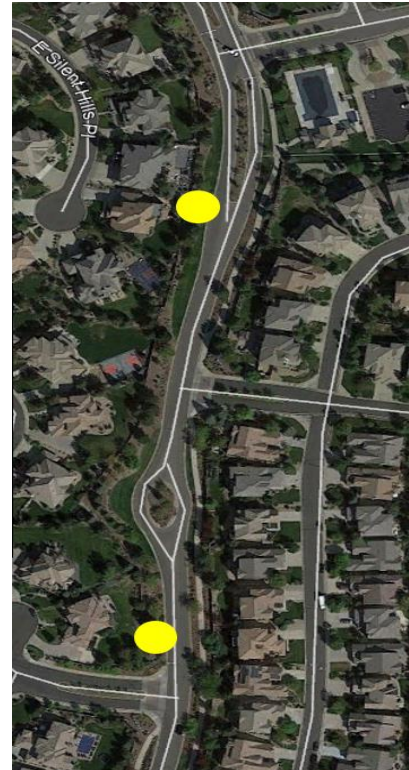
2. Segment 2 - Winding Hill Avenue to Shadow Hill Circle

Segment 2 Study Area consists of a length between Winding Hill Avenue and Shadow Hill Circle of approximately 1,150 feet. The following data summarizes the findings of this segment:

- 110 trips per day (Average)
- Minimum Speed = 8.6 MPH
- Maximum Speed = 51.0 MPH
- **85th Percentile Speed = 36.4 MPH**

There is one intersection within this segment of which no volume or speed data was collected and analyzed for this study. The intersecting street was Sunset Hill Circle. Since no data was collected for this movements, the only trips accounted for with this data set is for movements completed from the intersection of Winding Hill Avenue to Shadow Hill Circle.

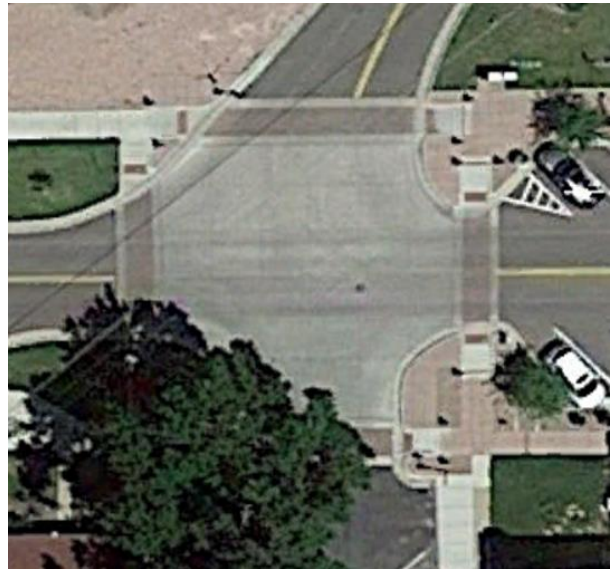
2. Option #2 - Pedestrian Crossing Improvements

Improvements to the geometry of three intersections (Shadow Hill Circle South, Shadow Hill Circle North, and Hidden Hill Place) including modifying curb returns to create bump outs, updating handicap ramps, and the option of creating a raised intersection or crosswalks. By modifying the curb returns, this creates a shorter crossing distance for pedestrians. This also creates a traffic calming effect by narrowing the pavement section. The estimated project costs for design and construction of these improvements are \$50,000 to \$150,000 dependent upon repaving the intersection.
